## METALLURGICAL LABORATORY FAILURE ANALYSIS CASE STUDY

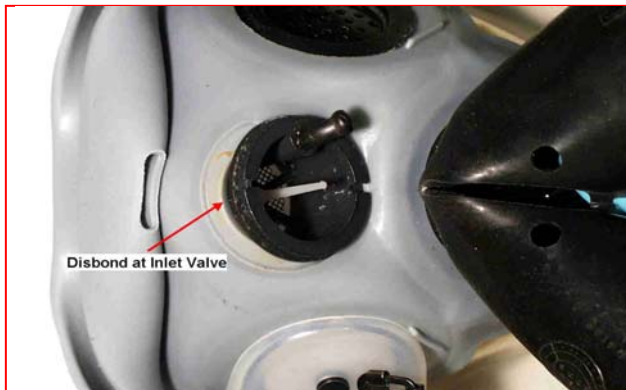
Disbond Location

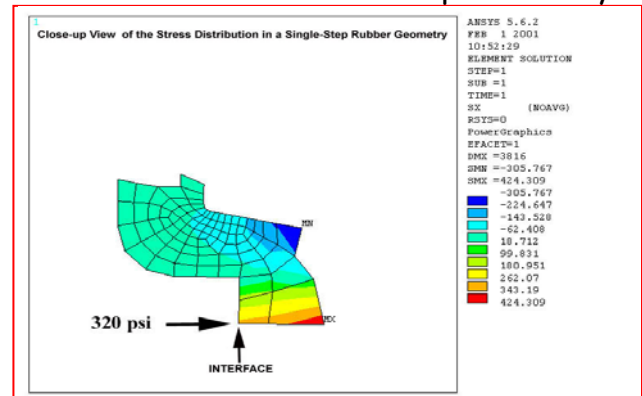
Stress Distribution One-Step Geometry

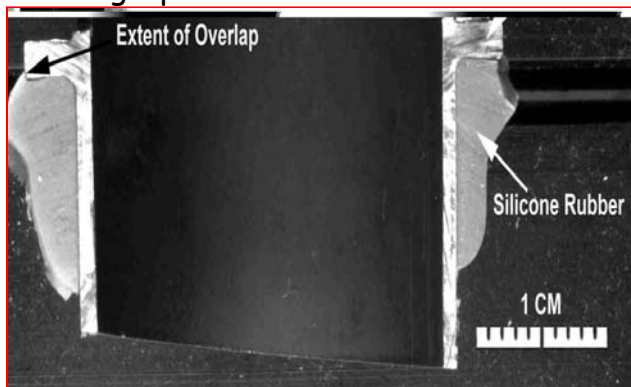
Metallographic Cross Section

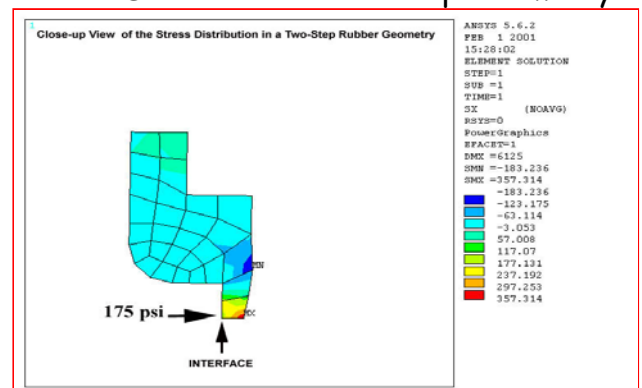
Stress Distribution Two-Step Geometry
