METALLURGICAL LABORATORY FAILURE ANALYSIS CASE STUDY

Description	Arthroscopic Shaver failure
Problem	Shaver failed during surgery. Fractured piece was removed from the shoulder by follow-on surgery and analyzed.
Analysis	Failure was caused by defective brazing that had bonded the outer surface of the failed shaver tip to the inner surface of the arthroscopic tool body.
Resolution & Recommendations	Develop a brazing process validation plan and use NDI technique to ensure the presence of sufficient braze volume.

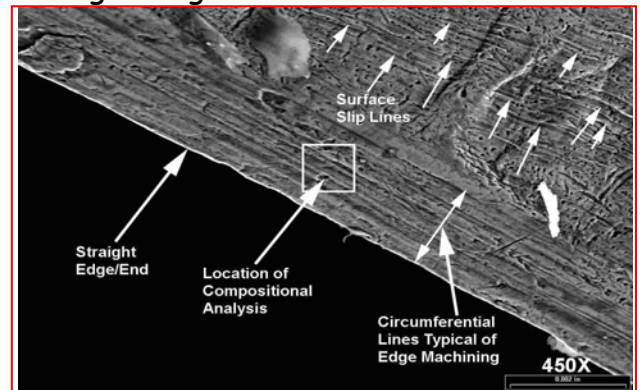
Straight Edge- Not A Fracture Site

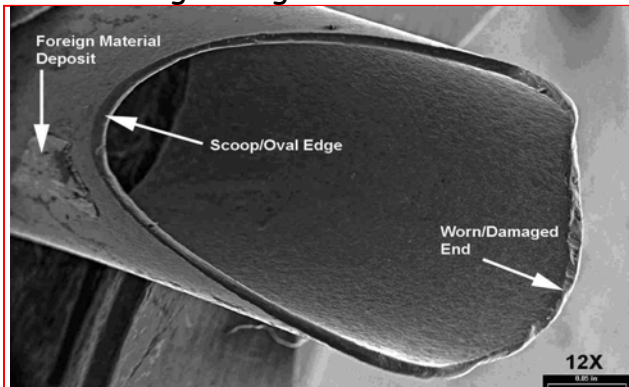
Oval/Damaged Edges- Not Fracture Sites

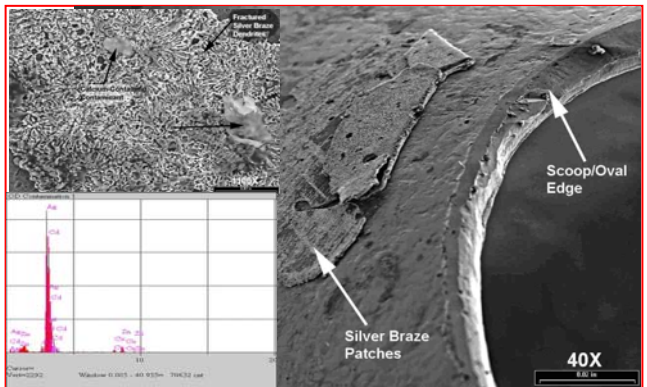
Braze On Outer Surface- Failure Site
