METALLURGICAL LABORATORY

FAILURE ANALYSIS CASE STUDY

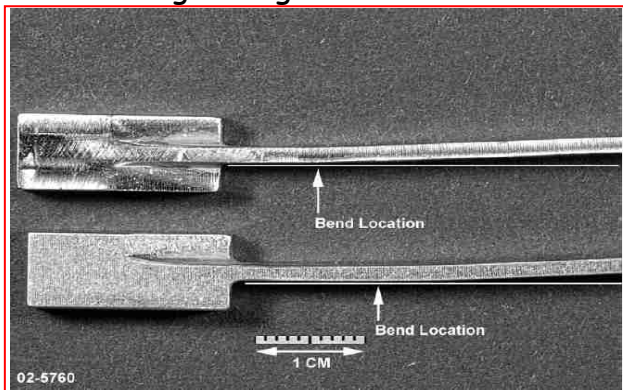
Link bending during -70 F Tests

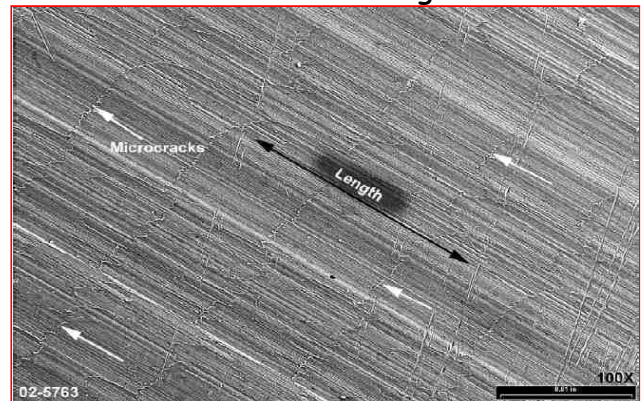
Microcracks due to Bending

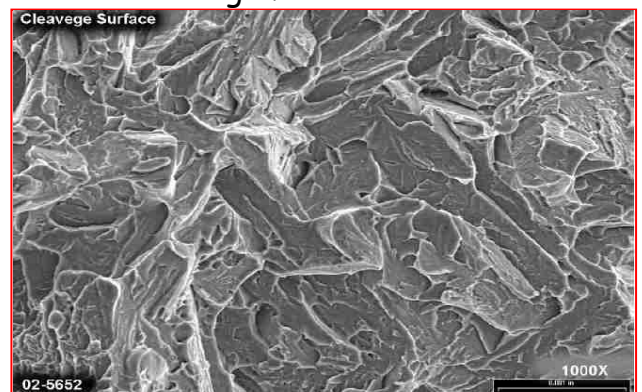
Brittle Cleavage Fracture
