## METALLURGICAL LABORATORY FAILURE ANALYSIS CASE STUDY

| Description | Failure in composite wound pressure vessel liner |

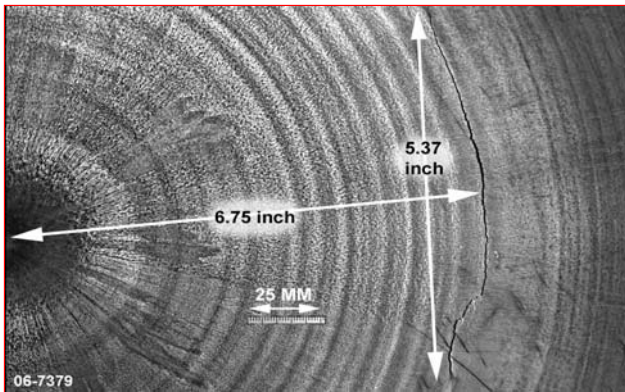
Fracture in Liner

| Problem | Spun aluminum alloy (6061-T6) liners failed during first proof pressurization cycle |

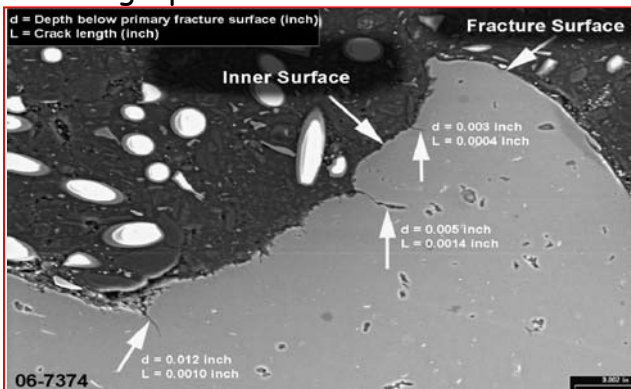
Metallographic Cross Section

| Analysis | Highly inhomogeneous deformation created local necks and local strains close to fracture strain |

| Resolution & Recommendations | Reduce deformation inhomogeneities by refining the grain size in extrusion stock |
