METALLURGICAL LABORATORY

FAILURE ANALYSIS CASE STUDY

Description	Repair strategies for aircraft antenna grounding structure
Problem	Aircraft antenna grounding structure showed external corrosion
Analysis	Incorrect alloy selection caused exfoliation corrosion damage. Externally visible corrosion was accompanied by deep damage, precluding practical repairs.
Resolution & Recommendations	Change alloy from 2024 to 6061 to prevent exfoliation corrosion damage

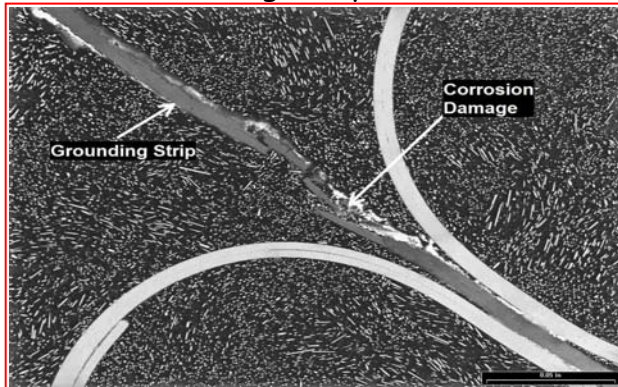
2024 Al Grounding Strip Cross Section

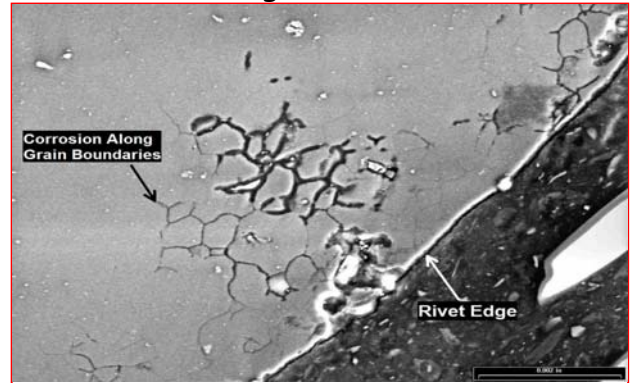
2024 Al Rivet Edge Corrosion

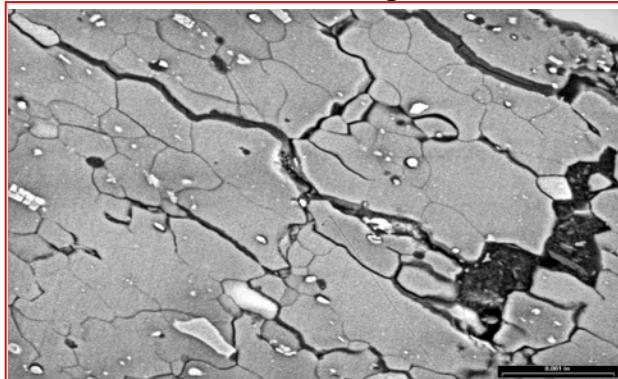
2024 Al Exfoliation Damage

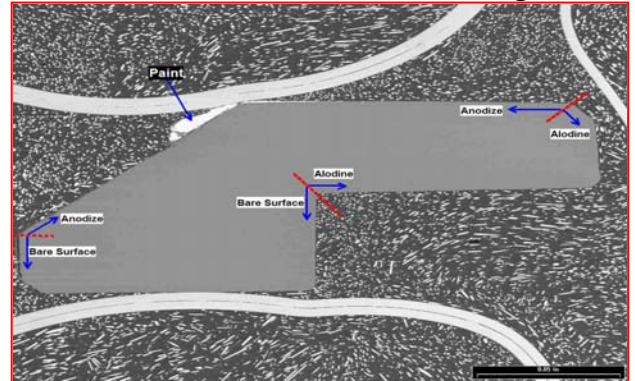
6061 Insert W/O Corrosion Damage
