METALLURGICAL LABORATORY

FAILURE ANALYSIS CASE STUDY

Description	Failure of T-Tap Assembly installed on a 69 KV - 437 Amp aboveground line
Problem	Determine whether the failure was an isolated incident or a systemic problem
Analysis	The failure occurred through a cascade that originated from inadequate clamping
Resolution & Recommendations	The failure was an isolated instance with potential to be system-wide if the clamping force was not correctly applied and monitored.

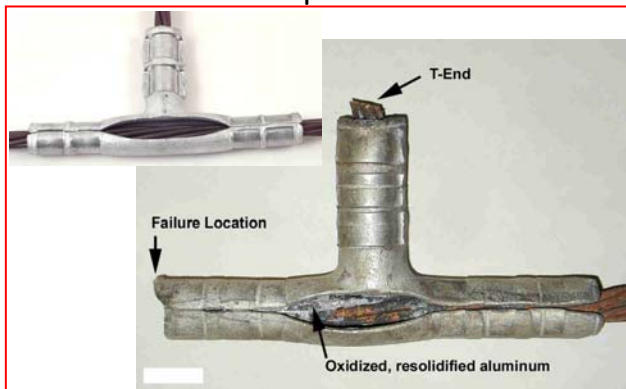
New and Failed T-Tap Assemblies

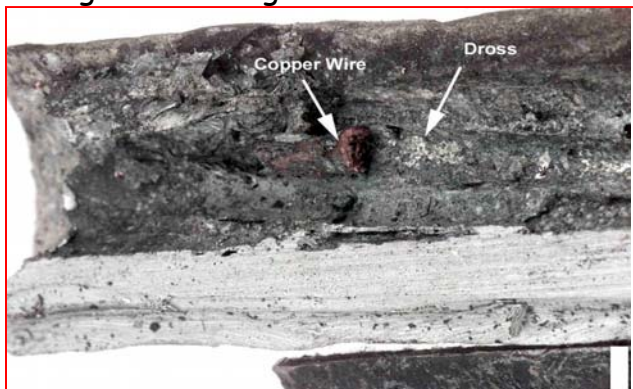
Arcing and Melting On the Inner Surface

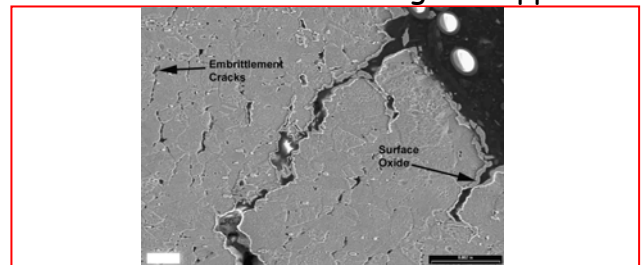
Embrittlement and Cracking of Copper
