METALLURGICAL LABORATORY FAILURE ANALYSIS CASE STUDY

Description	Failure of wireless Point-of-Sale devices
Problem	New Point-of-sale devices failed after storage or at various times during service
Analysis	Failure was caused by the copper ion bridging of two conductors on a terminal. Copper from terminals leached out and was transported due to corrosive attack of tin-lead plating by contaminants released from uncured epoxy of a chip-on-board assembly in close proximity.
Resolution & Recommendations	Extend epoxy curing to remove corrosive ion source

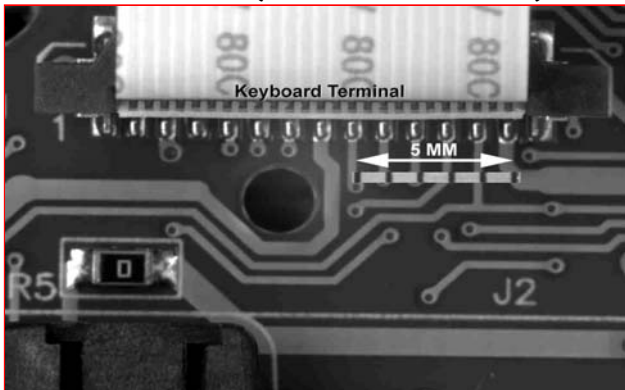
Failure Location (Cable Termination)

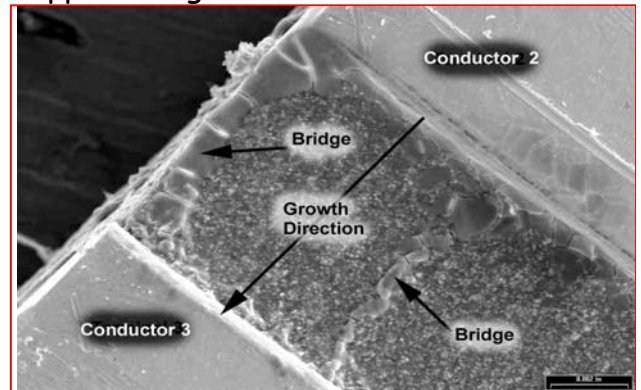
Copper Bridge Between Two Conductors

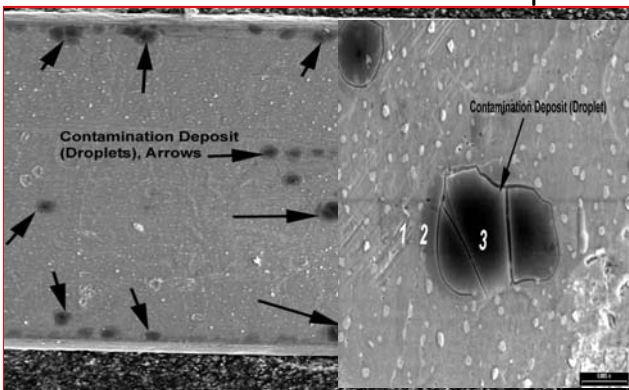
Contamination Overview and Closeup

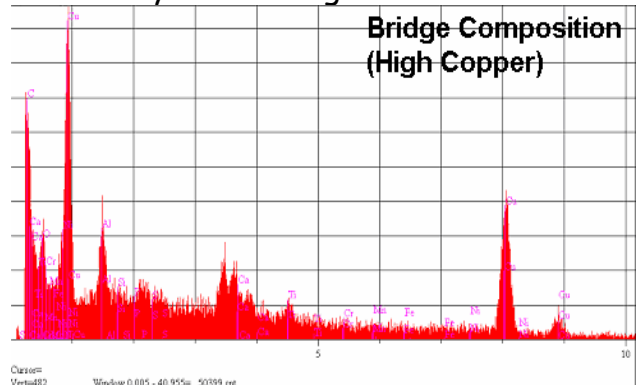
EDS Analysis of Bridge
