## METALLURGICAL LABORATORY FAILURE ANALYSIS CASE STUDY

Description	Mass transit bus heater core failure
Problem	Heater cores showed susceptibility to failure in service, primarily by fracture of copper tubing
Analysis	Failure was caused by high cycle fatigue due to mechanical (rather than thermal) variable-amplitude vibratory stresses. Cracks propagated in a corrosion-fatigue mode.
Resolution & Recommendations	Reduce joint stresses through the use of flexible couplings

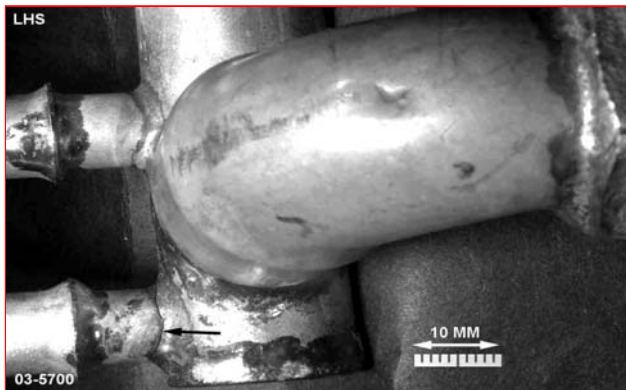
Failure Location

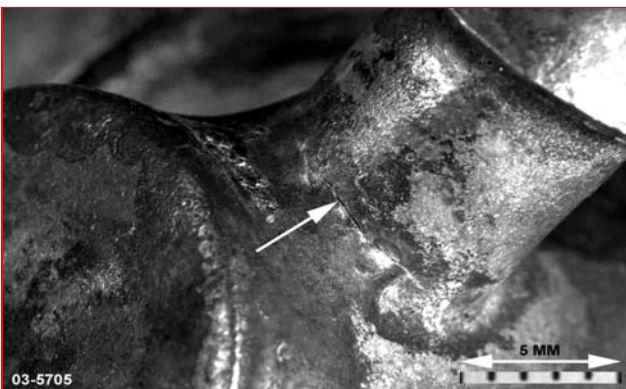
Failure Location

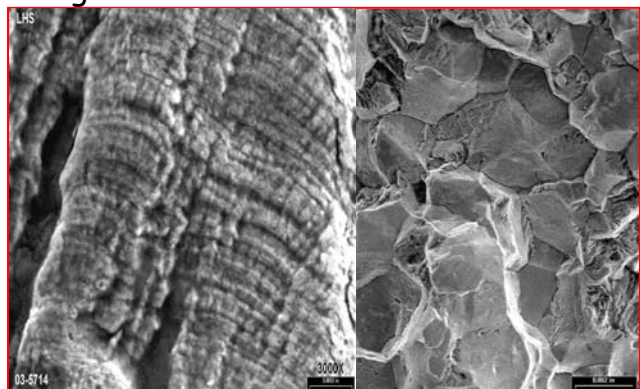
Fatigue Striations and IG Fracture
