METALLURGICAL LABORATORY

FAILURE ANALYSIS CASE STUDY

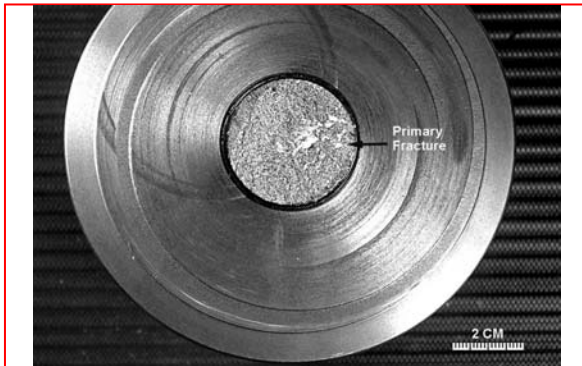
Fracture Location

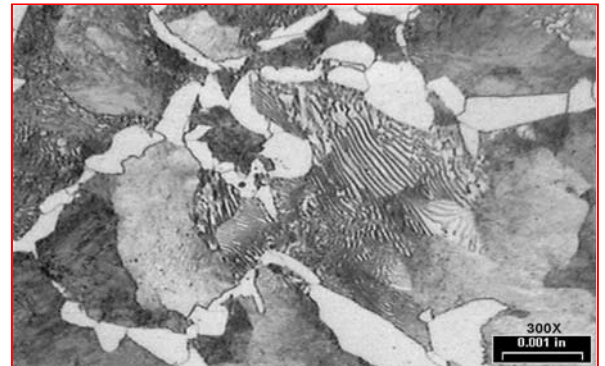
Steel Microstructure

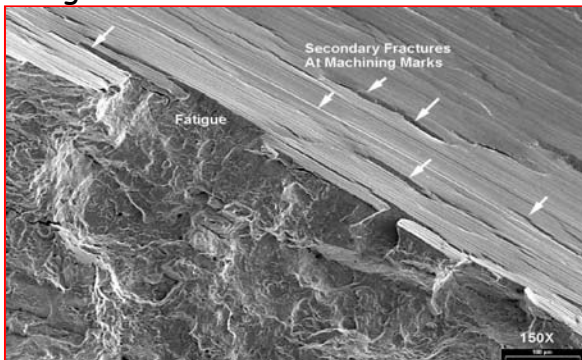
Fatigue Crack Initiation

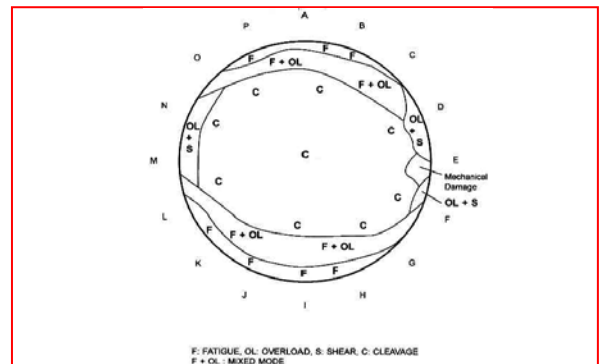
Summary of Crack Transition Modes
